National Aeronautics and Space Administration

NASA-DoD Lead-Free Electronics Project

DRAFT Joint Test Report

July 2011

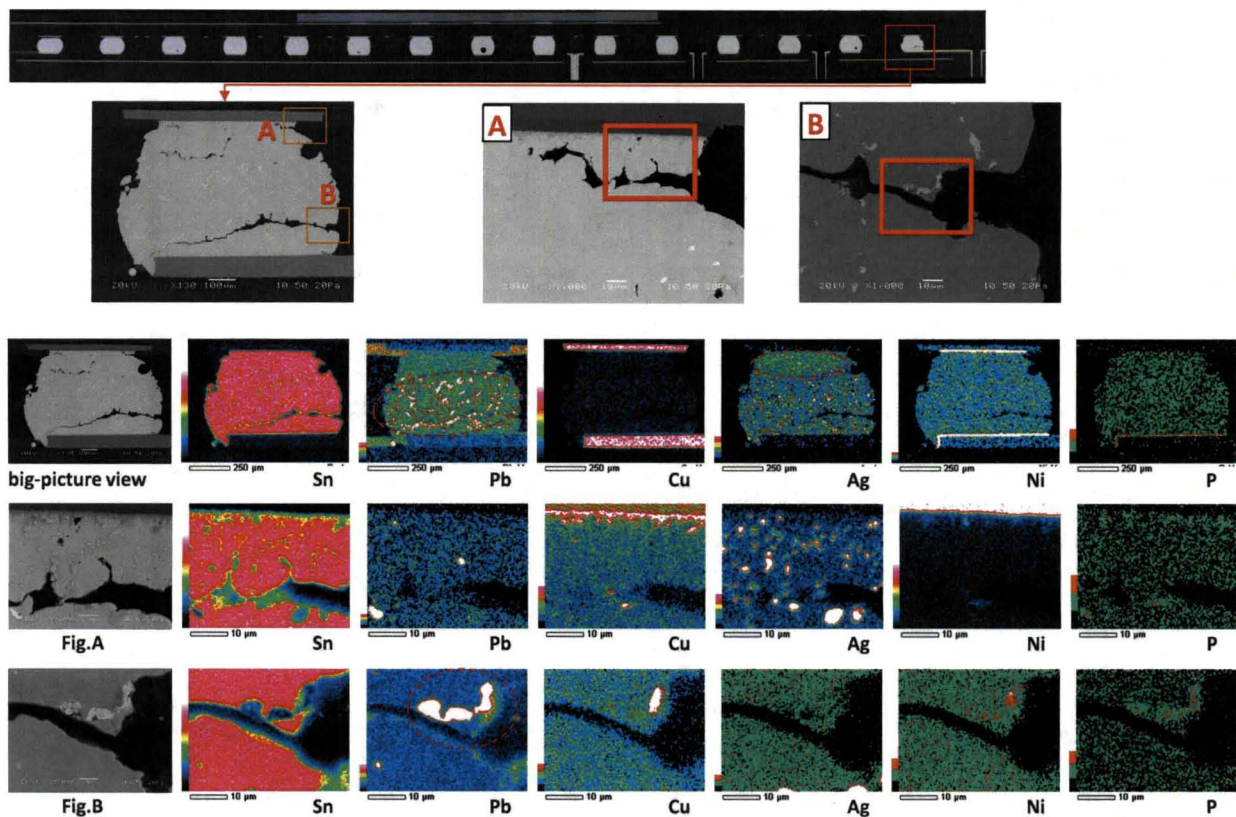
Figure 82 - TV158 U6; SEM Mapping

SEM mapping in Figure 82 shows segregation of Ag around land on component and segregation of Pb around PWB land. Higher concentrations of Pb detected in the cracking / breaking area.

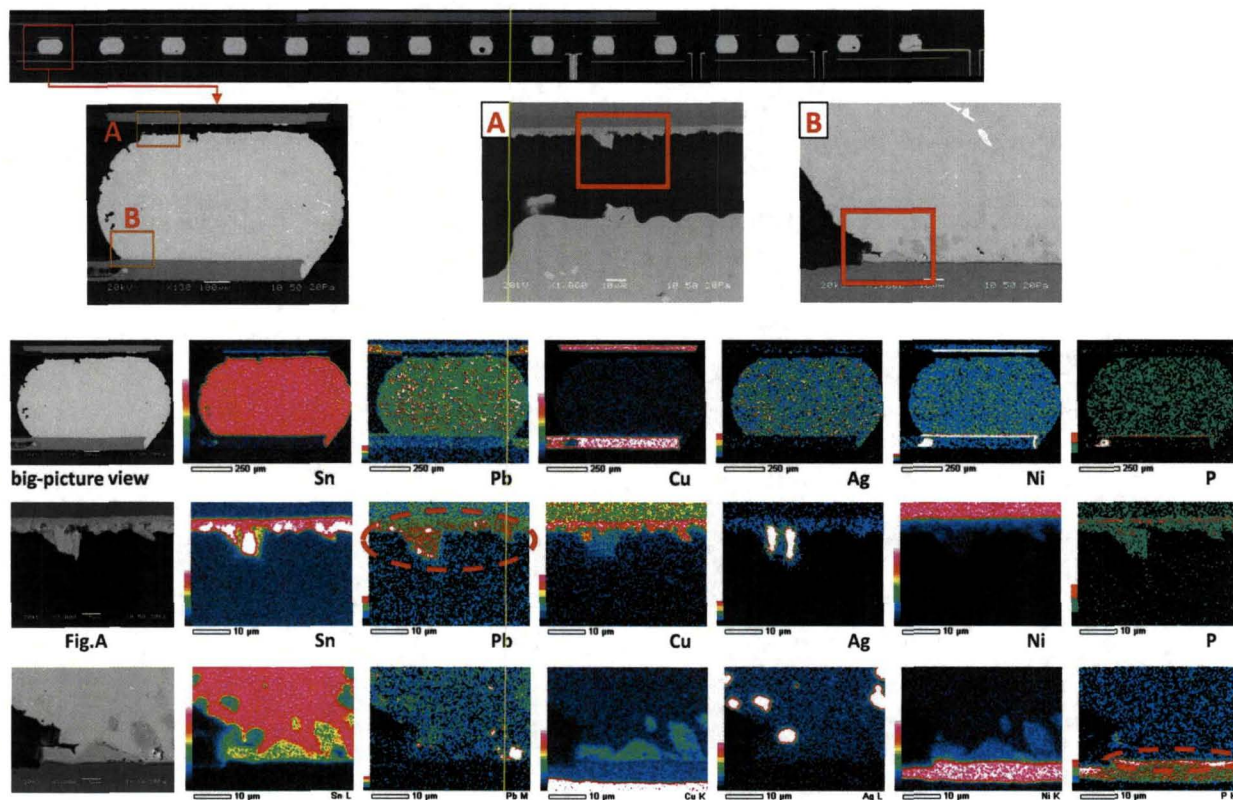
Figure 83 - TV158 U6; SEM Mapping

SEM mapping in Figure 83 shows solder is well blended over all except around component land where higher levels of Pb and cracking were found. Segregation of P from the ENIG board finish, however, no cracking detected.

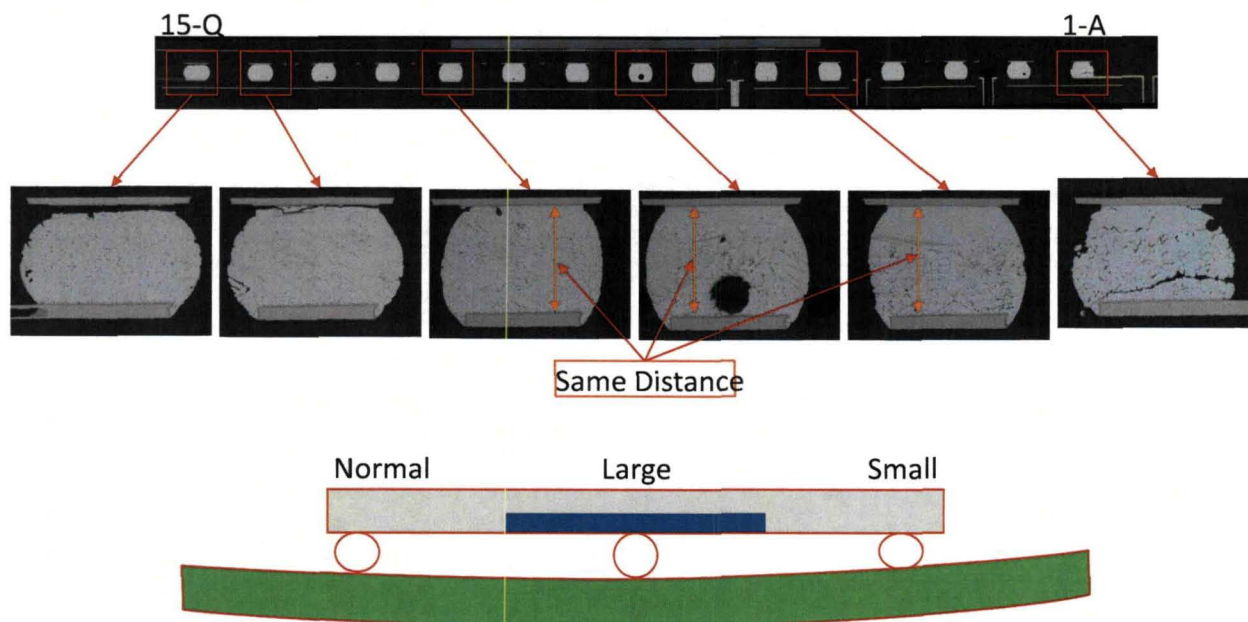
Figure 84 - TV158 U6; Cross-Sectional Micrographs Show Warping on BGA-225

In Figure 84 the distance between component and board at each sphere is almost the same under the chip in the center. The distance becomes smaller further to the end. Comparing the distance at [1-A] and [15-Q], [1-A] has smaller distance.

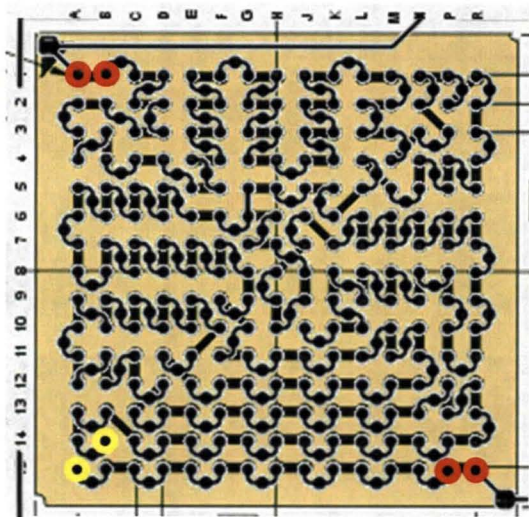
Figure 85 - TV180 U21; FA Results

Component location U21 is a reworked BGA-225 soldered with SAC305 on SAC405 component finish and replaced with SAC405 BGA-225 soldered with flux only. This component failed on cycle one and was reworked prior to combine environments testing.

In Figure 85 the yellow circles are solder joints with high resistance and red circles are failed solder joints that are open.

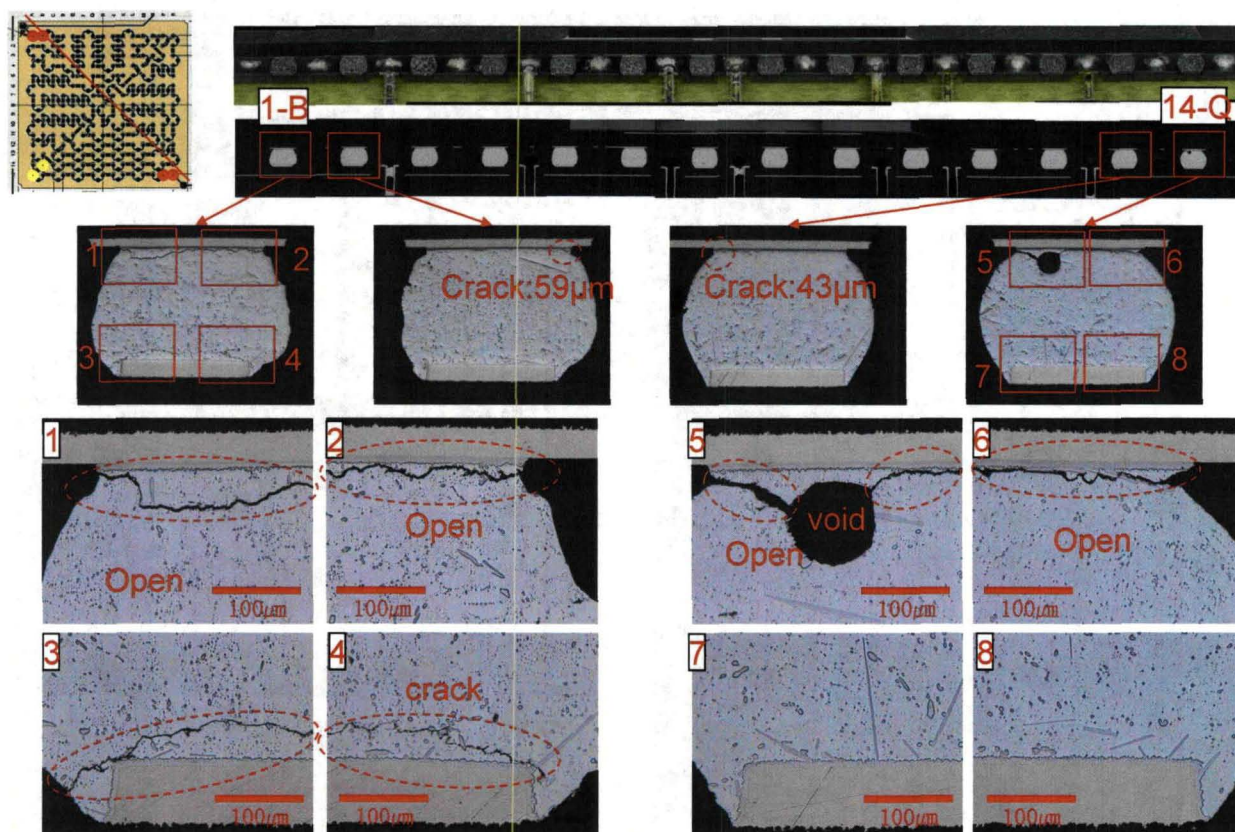
Figure 86 - TV180 U21; Cross-Sectional Micrographs

In Figure 86, the cross-sectional micrographs show cracking to opens on board side (1, 2, 5, 6).

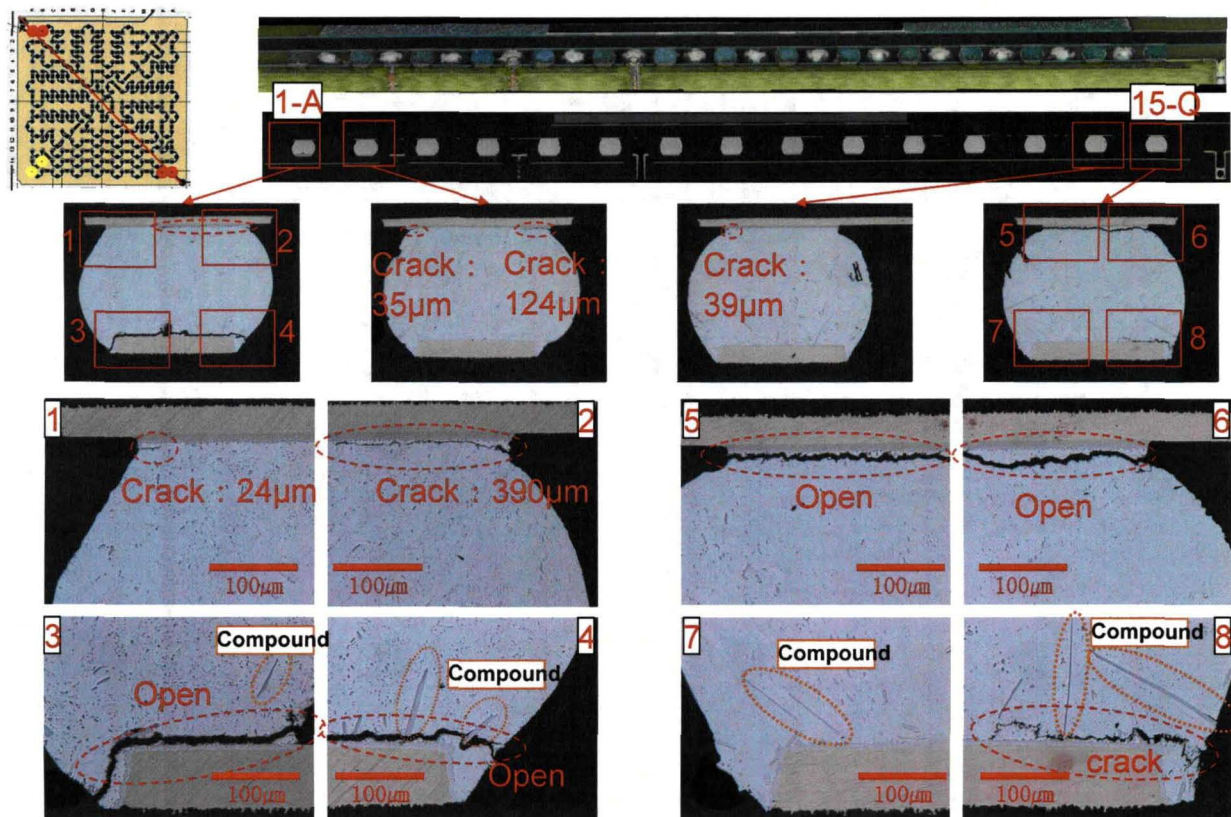
Figure 87 - TV180 U21; Cross-Sectional Micrographs

In Figure 87, the cross-sectional micrographs show cracking to open solder joints around both land on board and component (3, 4, 5, 6). Large intermetallic compounds observed around land on board (3, 4, 7, 8).

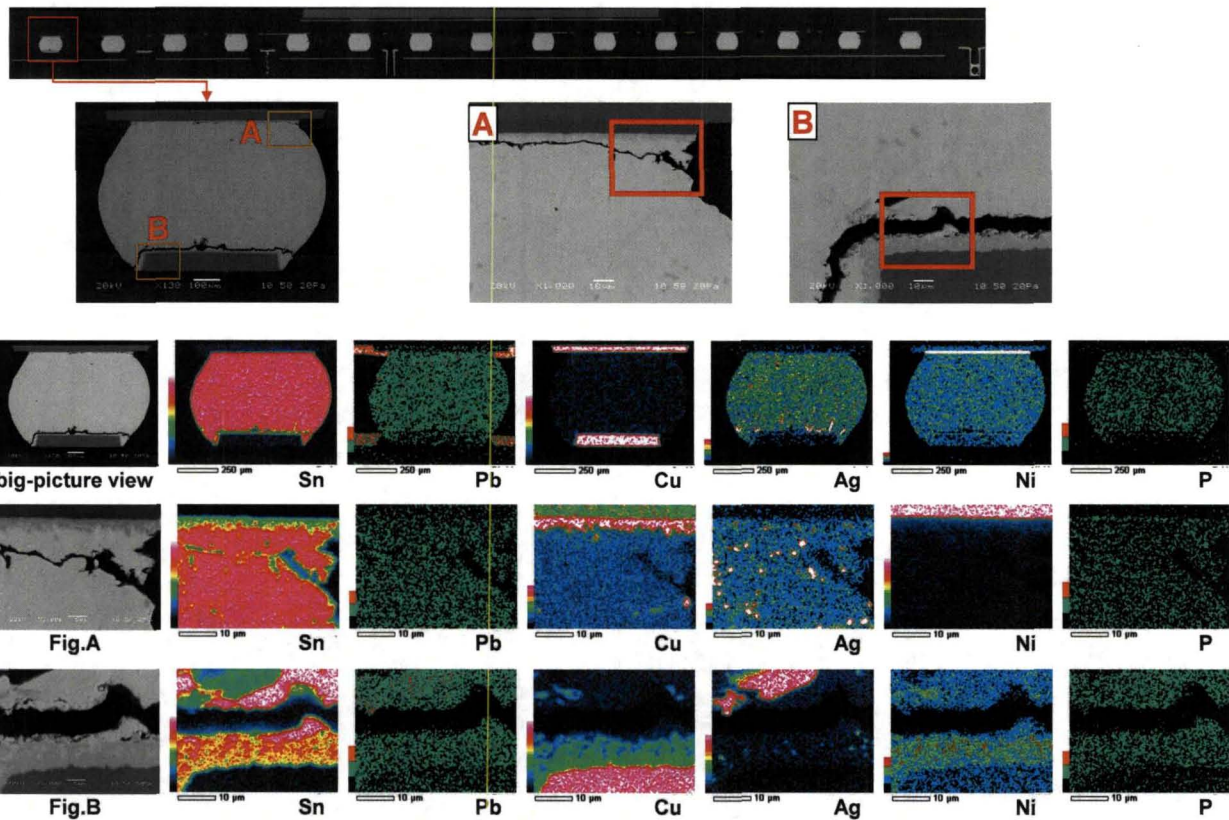
Figure 88 - TV180 U21; SEM Mapping

SEM mapping in Figure 88 shows cracks inside solder as well as cracking to open between IMC and solder, or inside solder.

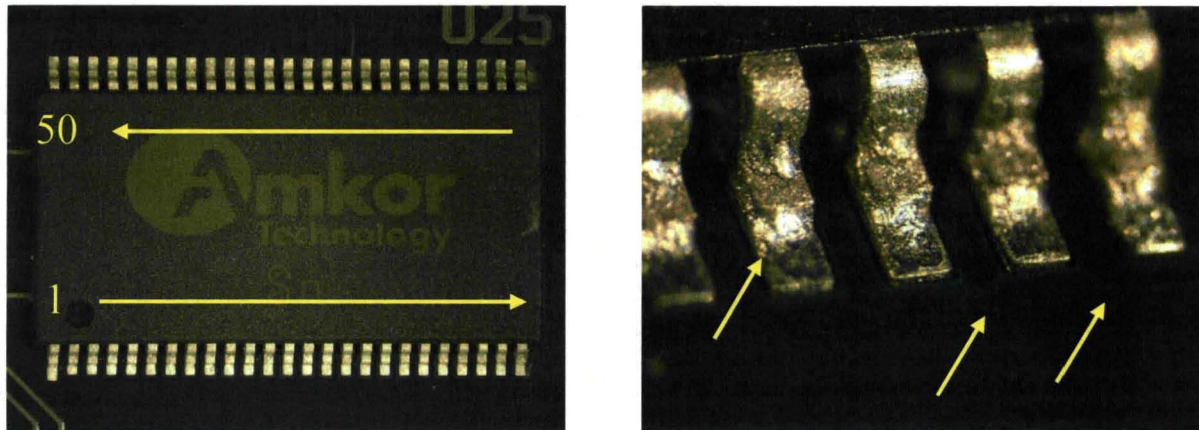
Figure 94 - TV181 U25; Optical Micrographs

In Figure 94, the optical micrograph on the left is the lead numbering and the image on the right is of leads 21-25. The arrows indicate cracked solder mask and the arrow on lead 22 indicates a solder disturbance at 49X magnification.

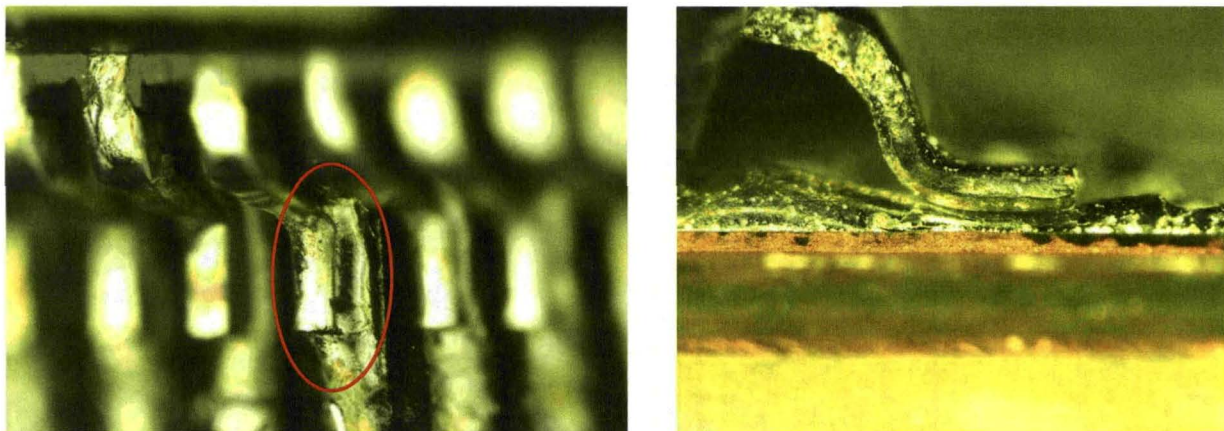
Figure 100 - TV183 U 41; Optical Micrographs of Suspect Lead

Component location U41 is a TQFP-144 from lead-free rework (Batch A), soldered with SAC 305 on SAC305 dip component finish. This component failed on cycle one and was not reworked.

Figure 100 shows inadequate solder joint resulting in no connection between the lead and the pad.

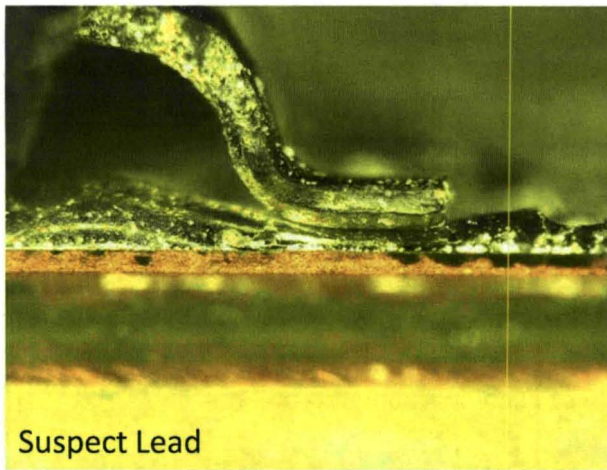
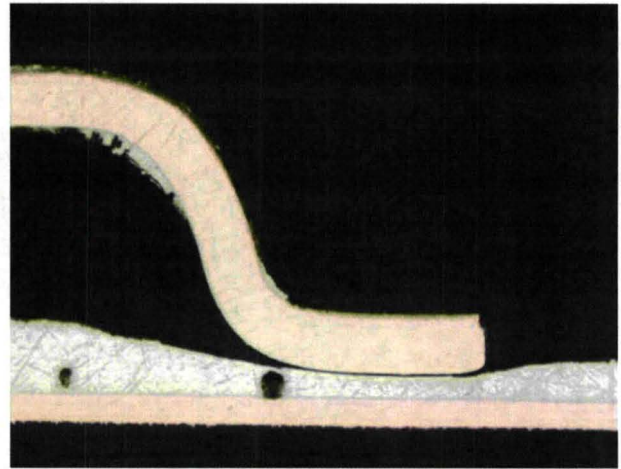
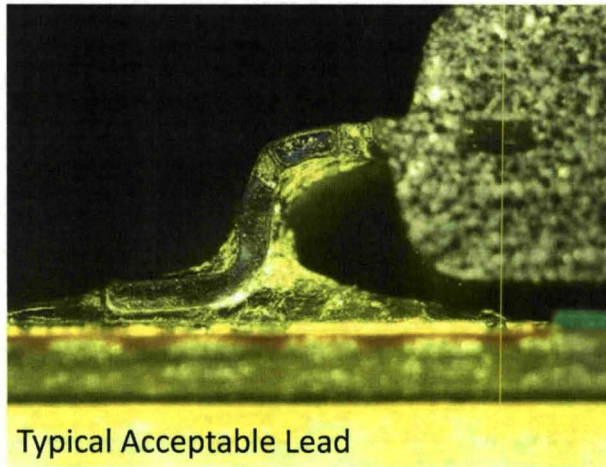
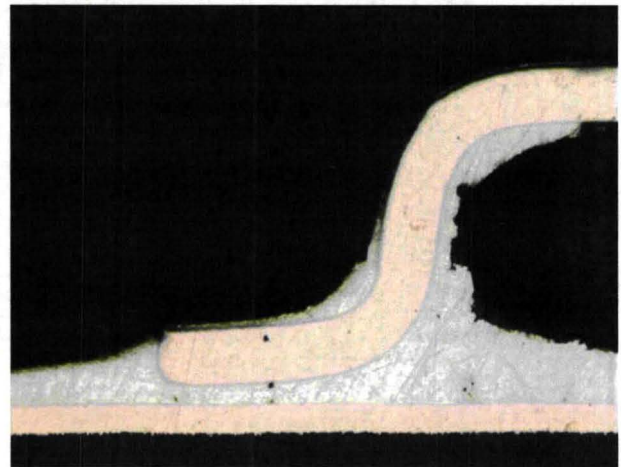
Figure 101 - TV183 U 41; Cross-Sectional Micrographs

Figure 101 shows cross-sectional micrographs of component leads comparing suspect lead to a typical acceptable lead.

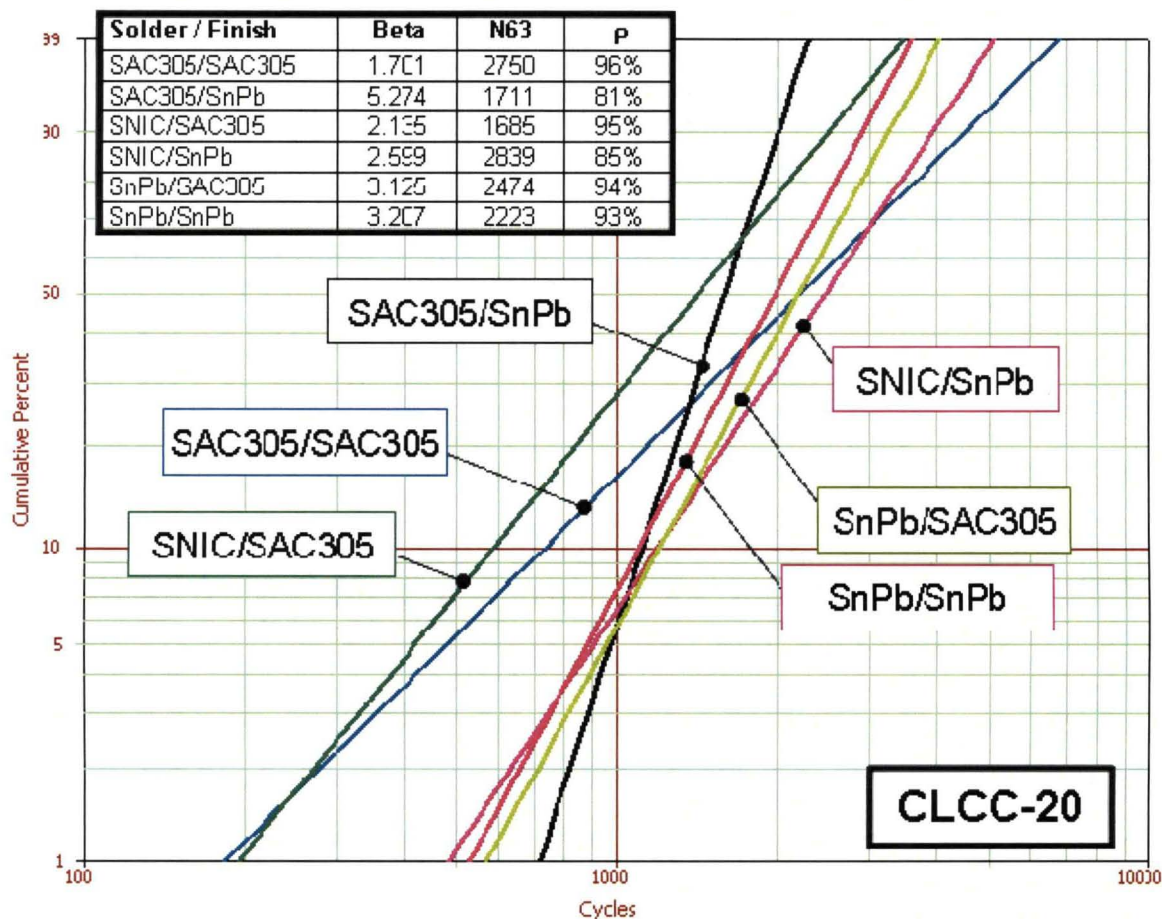
Figure 102 - CLCC-20 Weibull Plot

The CLCC-20 components had accumulated 74.6% population failure after the completion of 3600 thermal cycles. The CLCC-20 components were included on the test vehicles because of their poor reliability track record on electronic assemblies used in harsh environments. Industry data³ has demonstrated that the CLCC component style undergoes solder joint integrity degradation under IPC Class 3 use environments due to coefficient of thermal expansion (CTE) mismatch with the printed wiring assembly. CLCC-20 components had six different combinations (SAC/SAC, SAC/SnPb, SnPb/SAC, SnPb/SnPb, SNIC/SAC, SNIC/SnPb) tested and the results showed statistically significant differences in thermal cycle reliability. The completely Pb-free combinations (SAC/SAC and SNIC/SAC) were outperformed by solder/finish combinations that contained SnPb. The Weibull plot in Figure 102 summarizes the CLCC-20 thermal cycle test results.

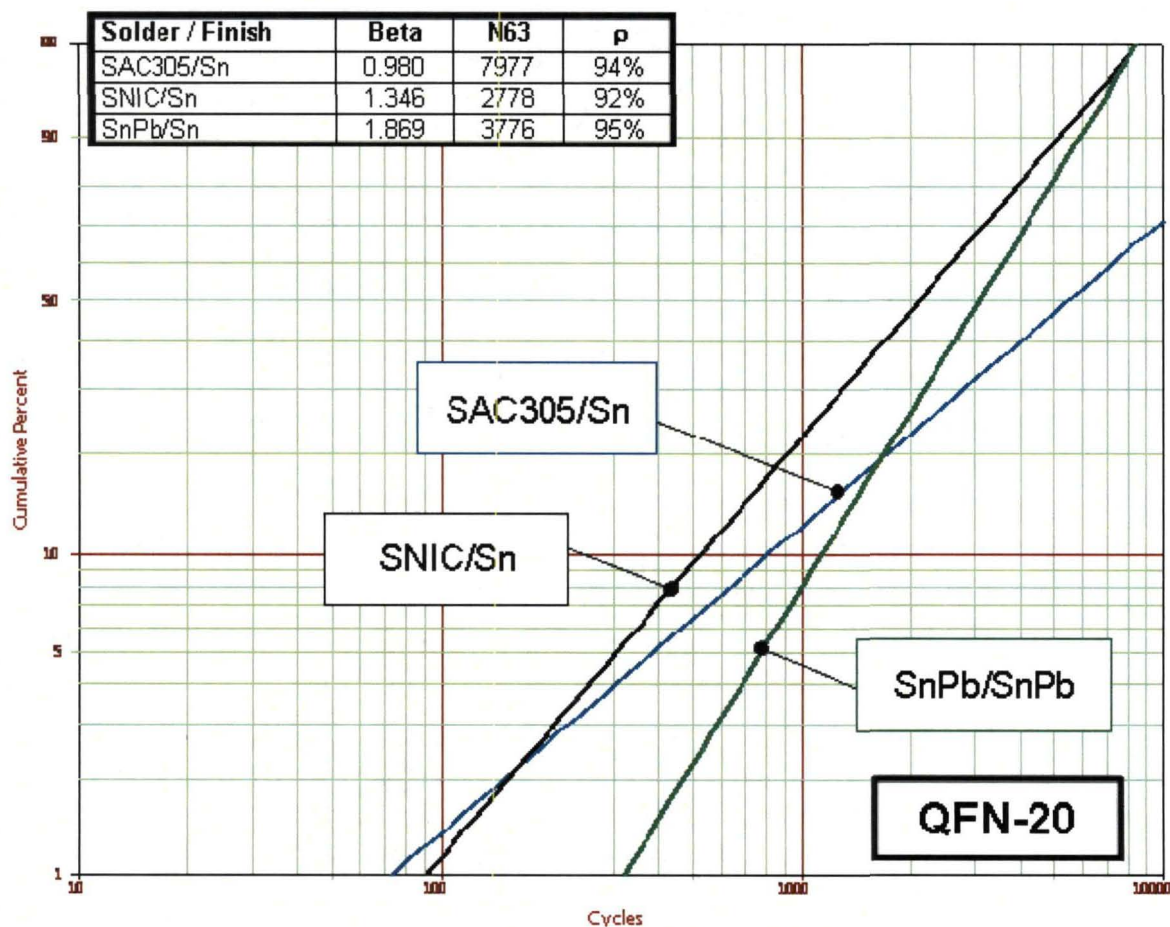
Figure 103 - QFN-20 Weibull Plot

The QFN-20 components had accumulated 52.2% population failure after the completion of 3600 thermal cycles and were the most robust component type in the investigation. QFN-20 components had three different combinations (SAC/Sn, SNIC/Sn, SnPb/Sn) tested and the results showed statistically significant differences in thermal cycle reliability. The SnPb/Sn combination has the best thermal cycle performance. The Weibull plot in Figure 103 summarizes the QFN-20 thermal cycle test results.

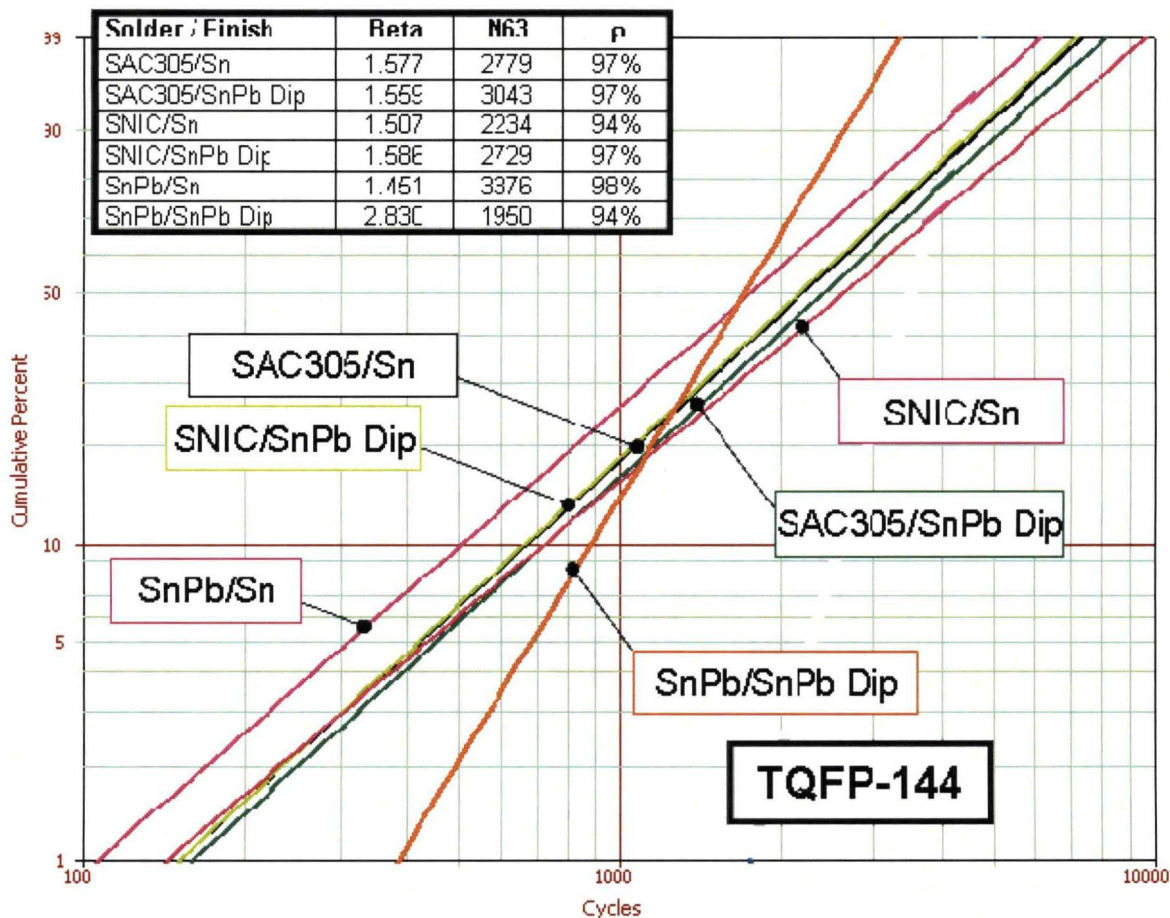
Figure 104 - TQFP-144 Weibull Plot

The TQFP-144 components had accumulated 73.4% population failure after the completion of 3600 thermal cycles. TQFP-144 components had eight different combinations (SAC/Sn, SAC/SnPb, SAC/SAC, SnPb/NiPdAu, SnPb/SnPb, SnPb/Sn, SNIC/Sn, SNIC/SnPb) tested for thermal cycle reliability. The SnPb/SnPb Dip combination had the best thermal cycle performance with all other combinations having similar performances. The Weibull plot in Figure 104 summarizes the TQFP-144 thermal cycle test results.

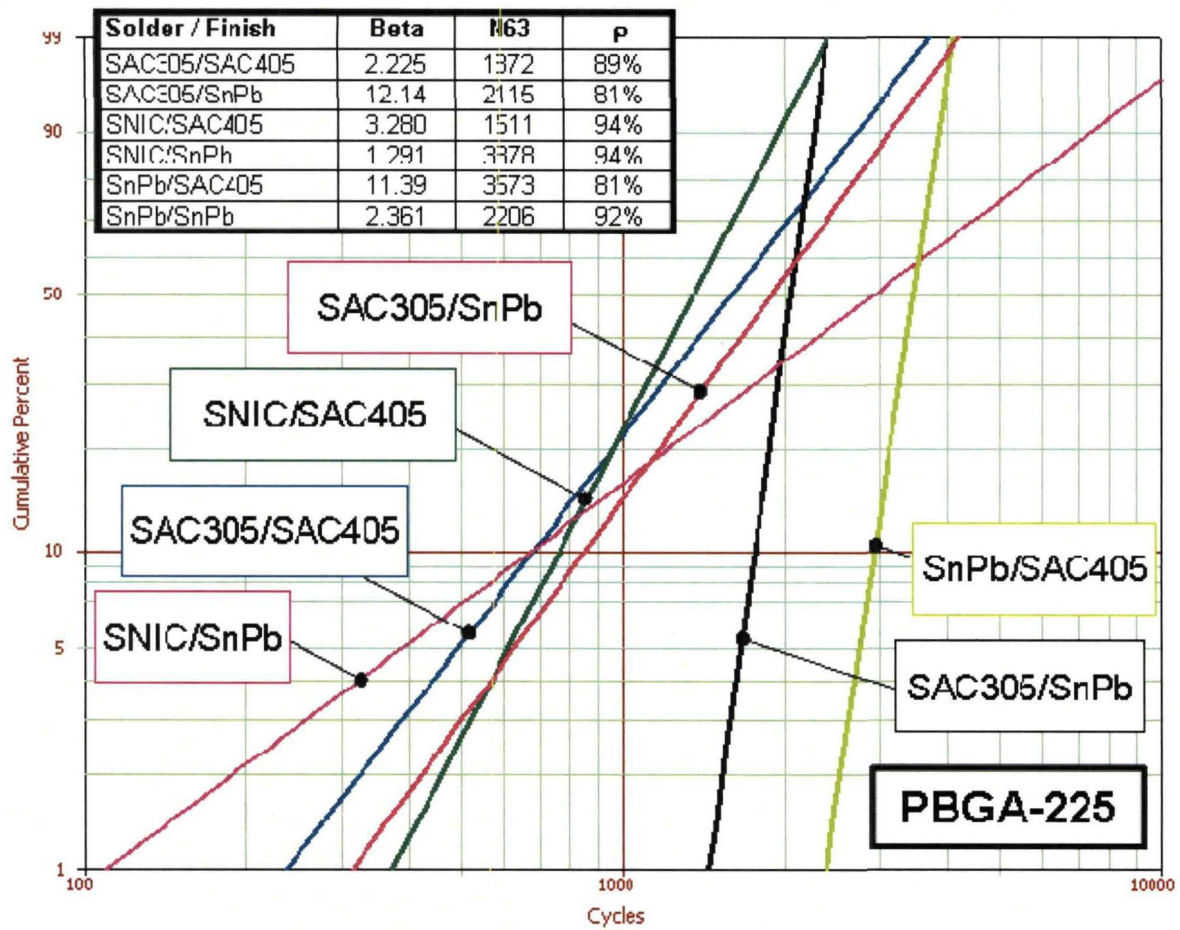
Figure 105 - PBGA-225 Weibull Plot

The PBGA-225 components had accumulated 56% population failure after the completion of 3600 thermal cycles. PBGA-225 components had six different combinations (SAC/SAC, SAC/SnPb, SNIC/SAC, SNIC/SnPb, SnPb/SAC, SnPb/SnPb) tested and the results showed statistically significant differences in thermal cycle reliability. The SnPb/SAC405 and the SAC305/SnPb had the best performance compared to the other combinations as shown in Figure 105. As shown in Figure 106, BGA components that were reworked, i.e. “1 RWK” exhibited similar reliability to their counterparts on the Reworked test vehicles that were not reworked.

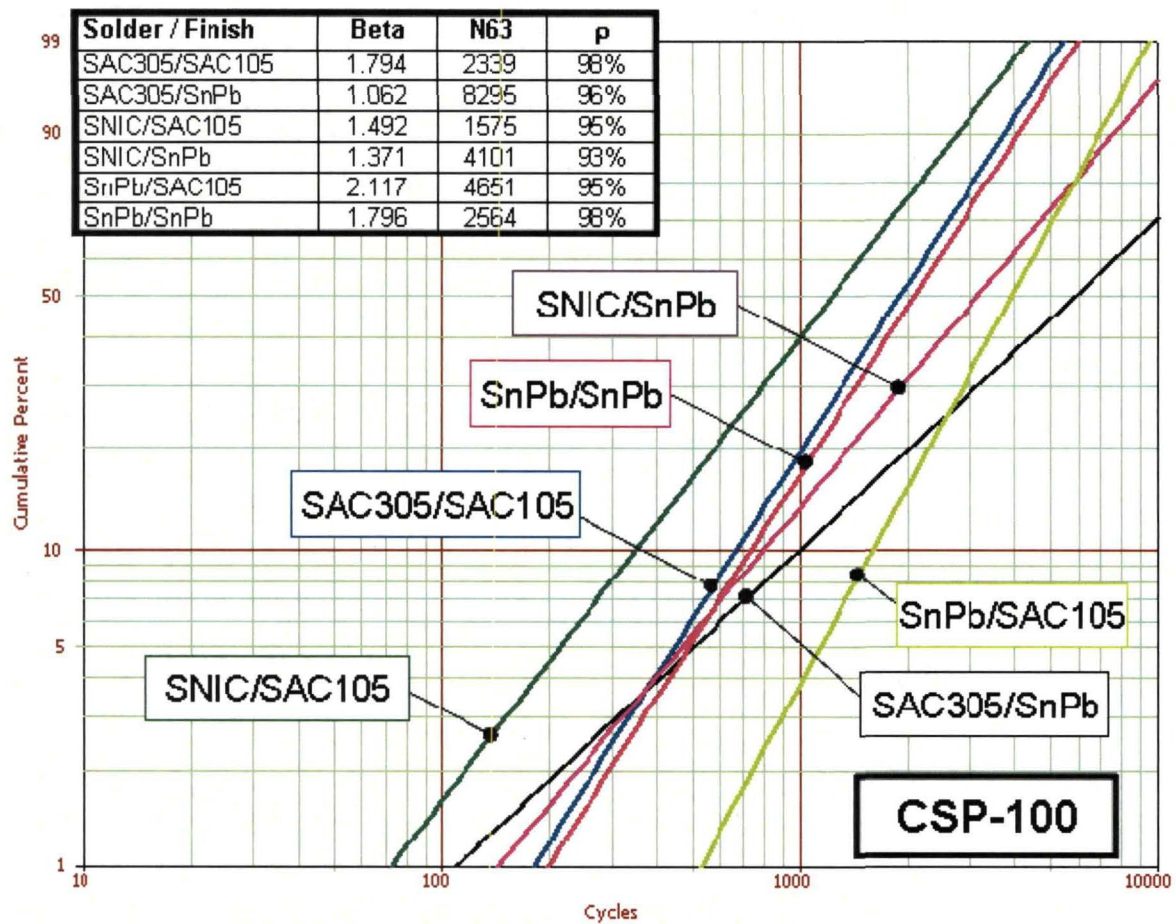
Figure 107 - CSP-100 Weibull Plot

The CSP-100 components had accumulated 62.3% population failure after the completion of 3600 thermal cycles. CSP-100 components had seven different combinations (SAC/SAC105, SAC/SnPb, SNIC/SAC105, SNIC/SNIC, SNIC/SnPb, SnPb/SAC105, SnPb/SnPb) tested and the results showed statistically significant differences in thermal cycle reliability as shown in Figure 107. The SnPb/SAC105 had the best performance and the SNIC/SAC105 had the poorest performance of the combinations tested. The reworked CSP-100 components (Figure 108) generally showed higher reliability than the manufactured components not reworked on the same test vehicle.

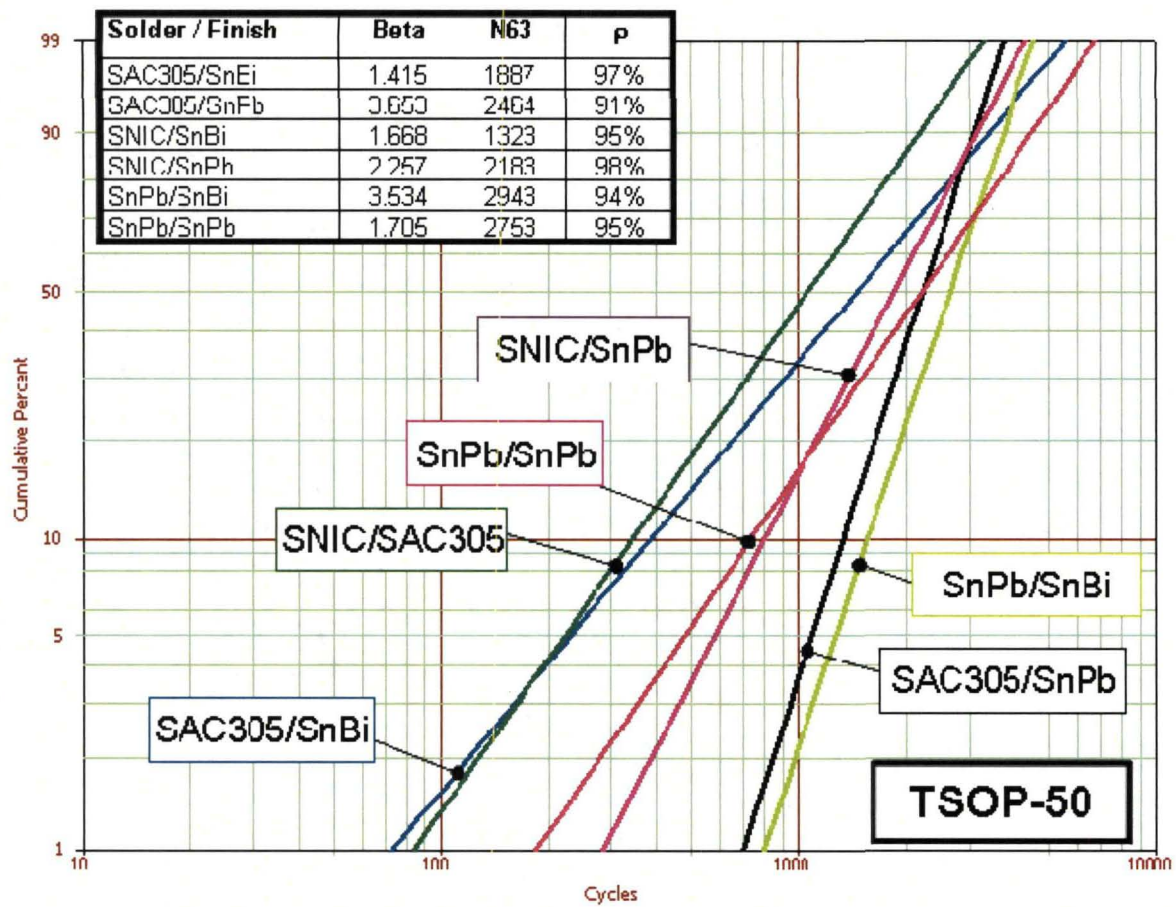
Figure 109 - TSOP-50 Weibull Plot

The TSOP-50 components had accumulated 71.5% population failure after the completion of 3600 thermal cycles. TSOP-50 components had nine different combinations (SAC/SnPb, SAC/SnBi, SAC/Sn, SNIC/SnPb, SNIC/SnBi, SNIC/Sn, SnPb/SnBi, SnPb/Sn, SnPb/SnPb) tested. The lead (Pb) containing combinations slightly out performed the Pb-free combinations tested. The rework TSOP-50 components exhibited significantly different trends compared to those on the manufactured test vehicle. These results require further statistical review before drawing any conclusions. The Weibull plots in Figure 109 and Figure 110 summarize the TSOP-50 thermal cycle test results.

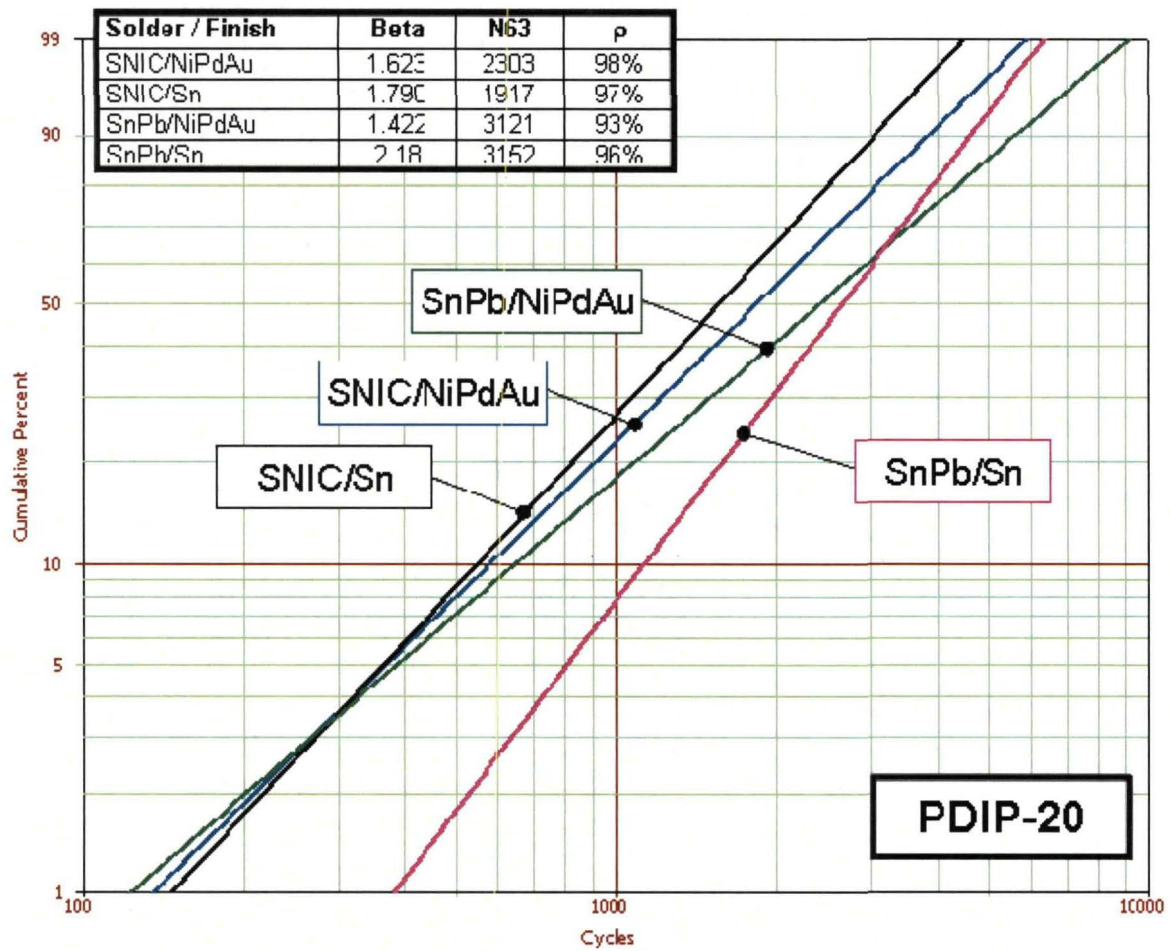
Figure 111 - PDIP-20 Weibull Plot

The PDIP-20 components had accumulated 72.7% population failure after the completion of 3600 thermal cycles. The solder joint failure behavior of the PDIP-20 components was a surprise to the consortia team as the PDIP-20 failure rate documented in the JCAA/JGPP investigation results was only 8% after 4743 total thermal cycles. PDIP-20 components had four different combinations (SNIC/Sn, SNIC/NiPdAu, SnPb/NiPdAu, SnPb/Sn) tested and the results showed statistically significant differences in thermal cycle reliability. The SnPb/Sn combination registered the best performance. The reworked PDIP-20 component thermal cycle performance was not statistically different than a non-reworked PDIP-20 component. Additional resources will be focused on determining the exact root cause of the unexpected PDIP-20 failure rates. The Weibull plots in Figure 111 and Figure 112 summarize the PDIP-20 thermal cycle test results.

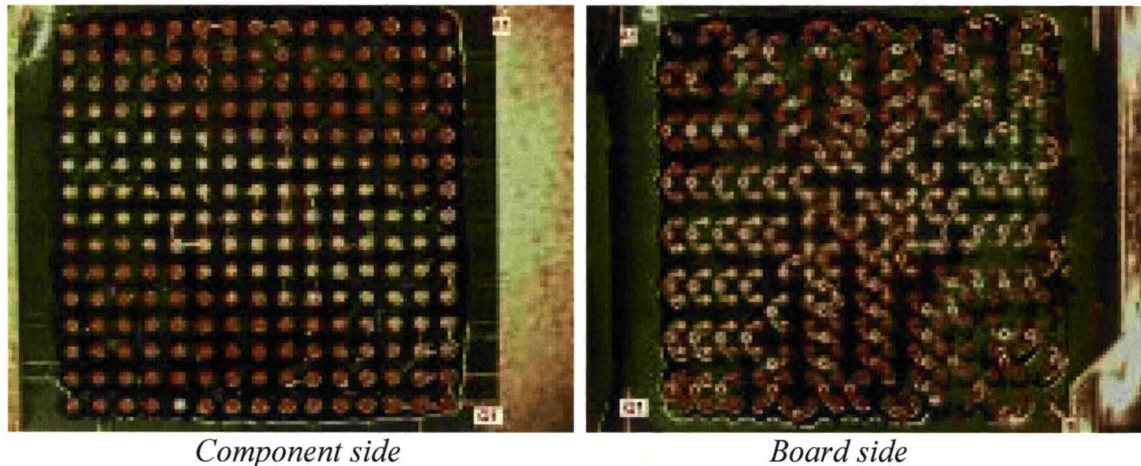
The main focus of the NASA drop test failure analysis was the 225 I/O plastic BGAs. This was because the vast majority of electrical failures on the test vehicle were these larger PBGAs. All CSPs electrically passed drop testing. For the PBGAs there was a wide range in number of drops until failure: 40% failed electrically within less than 6 drops and 99% failed electrically by 20 drops. Less than 1% of non-BGA components electrically failed after 20 drops. Pad cratering was the predominant failure mode for all samples destructively analyzed. Dye-and-pry and cross-sections of failed joints are shown below; Figure 114 and Figure 115.

Figure 114 - Typical Pad Cratering seen on BGA225 after Dye-and-Pry

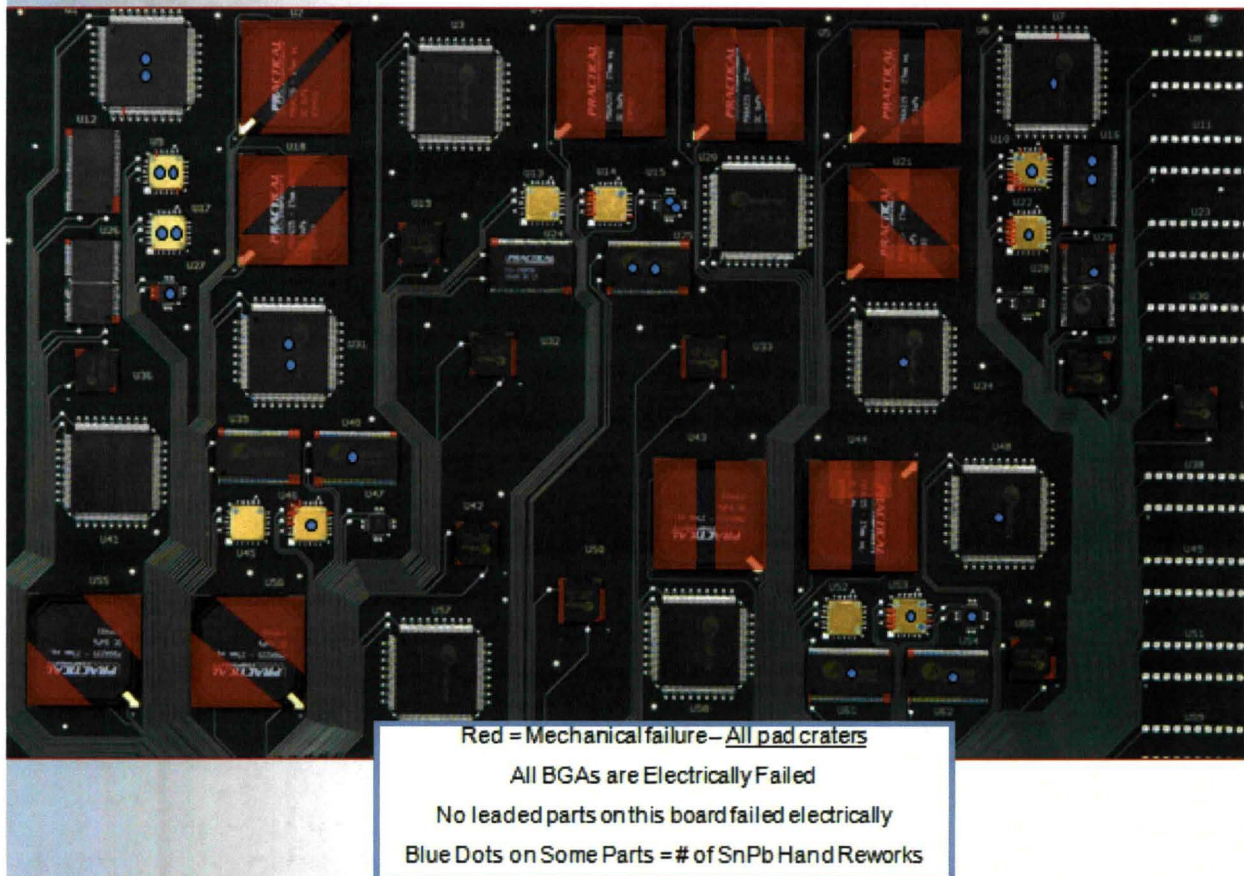
Figure 117 – Mechanical Failure Mapping

One of the cards tested, which had no electrically failing leaded parts, was chosen for dye & pry of all 63 parts in order to map the mechanical damage. Figure 117 summarizes the mechanical failure (red overlay) of one board after 20 drops at 500G. In-situ electrical data on BGAs showed that some PBGAs failed after as little as 5 drops – this implies that mechanical failure may have occurred after even fewer drops. Interesting to note that the board was held by posts in the 4 corners and as such the strain is not symmetrical across the card.

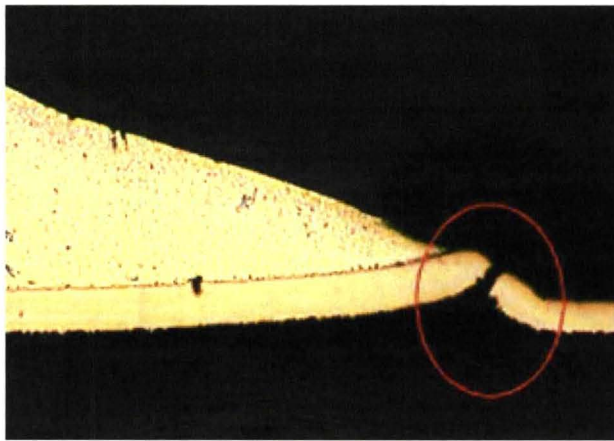
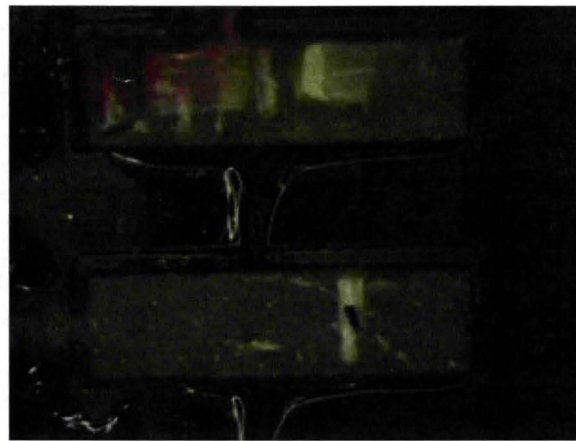
Pad cratering was the predominant failure mechanism in all components, as observed through both dye-and-pry and cross sectioning; Figure 118. In two cases the pad cratering was significant enough to break the trace and cause an electrical failure. However in most cases the trace remained intact and therefore no electrical failure was detected.

Figure 118 - Pad Cratering seen on CLCC-20

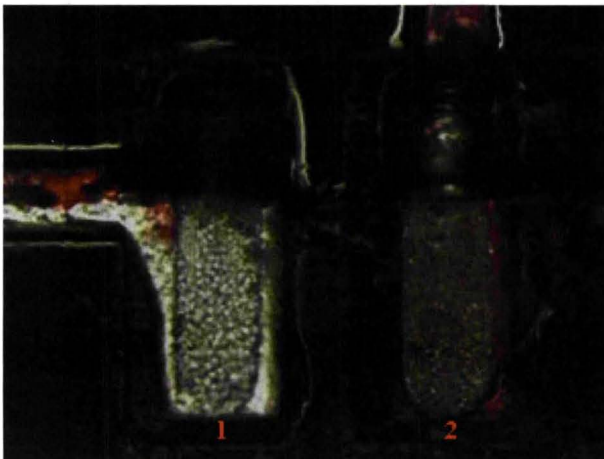
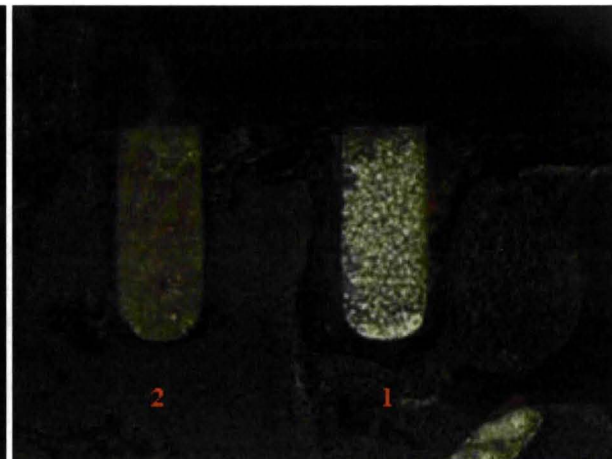
A small number of the analyzed solder joints had signs of solder fracture; however only in one case did this lead to an electrical failure; Figure 119. This indicates that, for the most part, the solder fractures did not penetrate through the entire solder joint.

Figure 119 - Dye and Pry of a QFN-20 showing dye penetration through the bulk solder

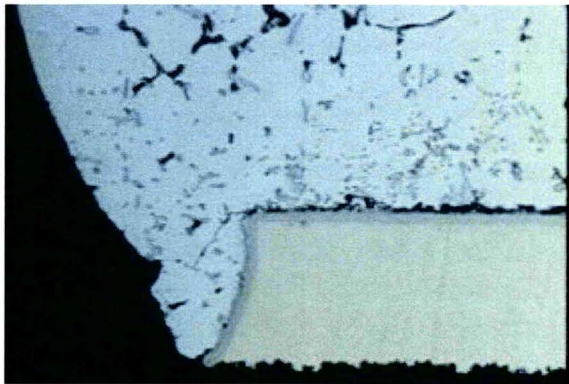
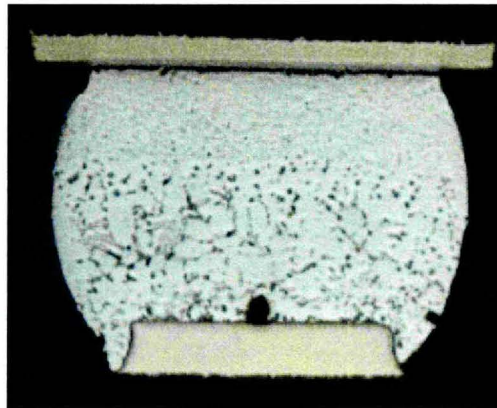
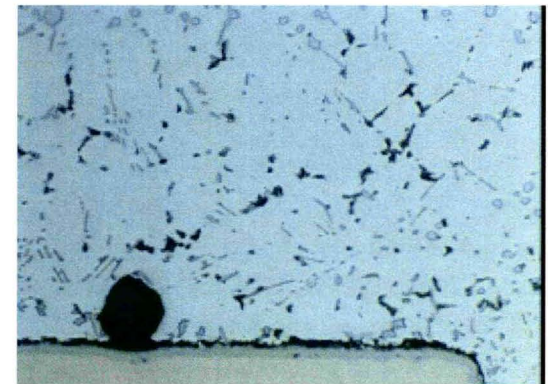
SAC BGA assembled in a conventional SnPb solder process. Failure in temperature cycling (-55 to 125°C) occurred in less than 150 cycles. This type of defect could escape current screening practices.

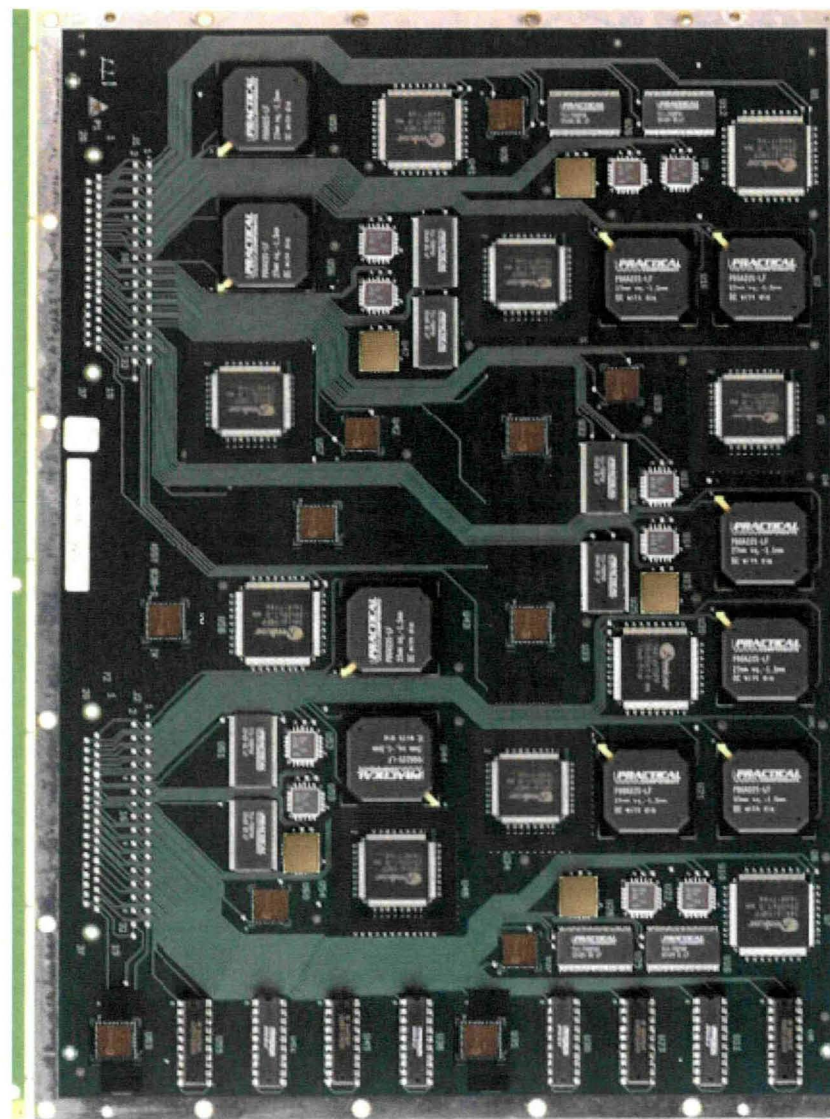
Test Vehicle Fabrication Issue #1

Trace Etching Issue
